# Mars Exploration Rover Heatshield Observation Campaign

For the first time ever, engineers were able to observe a heatshield on the surface of another planet after a successful entry through the atmosphere. A three-week heatshield observation campaign was conducted in December 2004 after the Mars Exploration Rover *Opportunity* exited “Endurance Crater.” By utilizing the rover’s scientific instruments, data was collected to make a qualitative assessment of the performance of the heatshield. This data was gathered to gain a better understanding of how the heatshield performed during entry through the Martian atmosphere. In addition, this unprecedented look at the heatshield offered engineers the opportunity to assess if any unexpected anomalies occurred. Once a survey of the heatshield debris was completed, multiple targets of interest were chosen for the collection of imaging data. This data was then used to assess the char depth of the thermal protection material, which compared well with design and post-flight computational predictions. Extensive imaging data was collected and showed the main seal in pristine conditions, and no observable indications of structure overheating. A

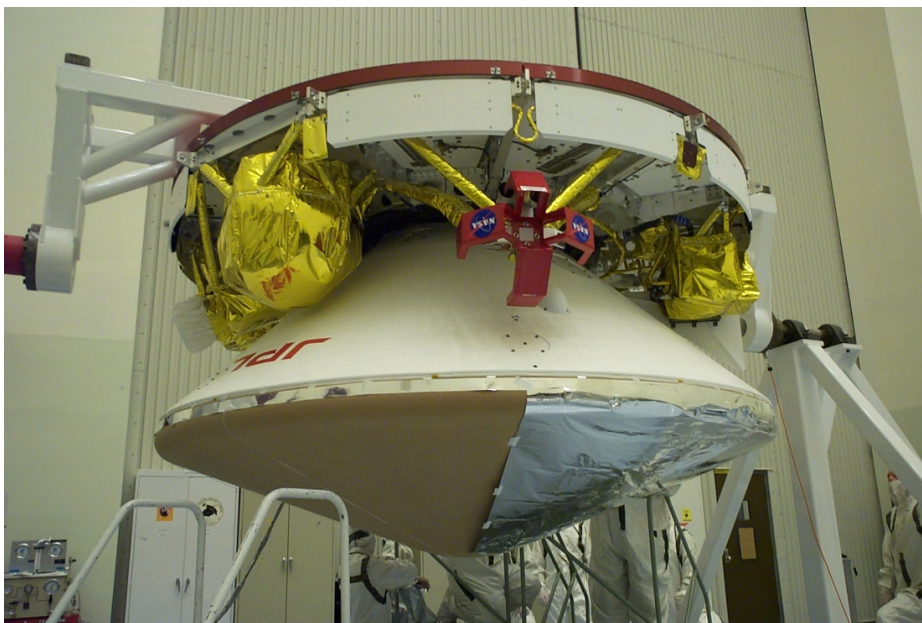
**Figure 3. MER spacecraft mated to cruise stage (half of external thermal blanket installed)**

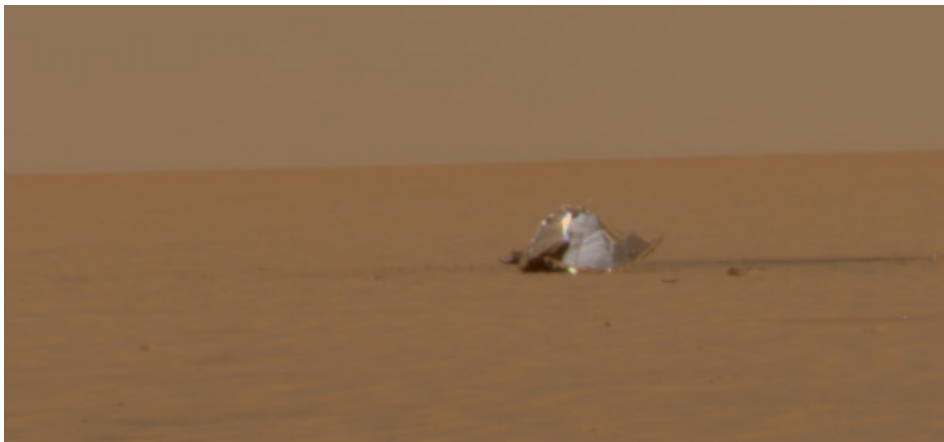
**Figure 6. Heatshield Debris Image from Sol 322 (Rover approximately 130 m away)**

Once *Opportunity* exited "Endurance" crater in December 2004, the rover began driving towards the heatshield. Figure 6 shows a PanCam image of the heatshield taken on Sol 322 as the rover was about 130 m away. At this point, it was clear that the heatshield was not intact after impacting the surface at about 75 m/s (170 mph). Although the heatshield's free-fall descent was expected to be generally stable, the flight dynamics of such a shallow dish could still result in a large range of impact attitudes.

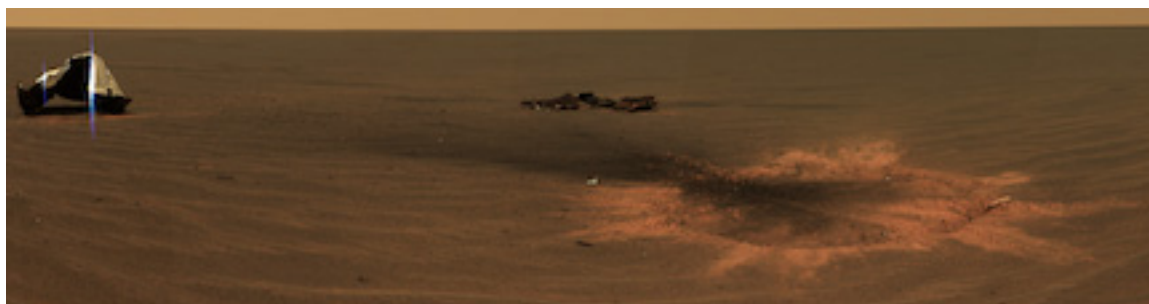
**Figure 7. Main heatshield, “flank piece”, and impact divot**

It was hoped that impact occurred at an angle that would preserve significant portions of the fragile TPS. However, as the rover approached, it became apparent that the conical heatshield had impacted nearly vertically, as witnessed by the circular symmetric shape of the impact divot, as shown in Figure 7. It appears that the western edge of the divot may have been the initial impact point, so the angle of attack could have been as much as 30-40 degrees. This event had the effect of breaking the nose loose and driving it through the structure to a fair distance away. As the rest of the conical structure drove itself into the soil, it broke apart along the pie-shaped manufacturing splice joints, flattening onto the surface, and resulting in most of the external surface impacting with a fair amount of energy. This was unfortunate in that it caused most of the exterior TPS to impact the ground, breaking up the

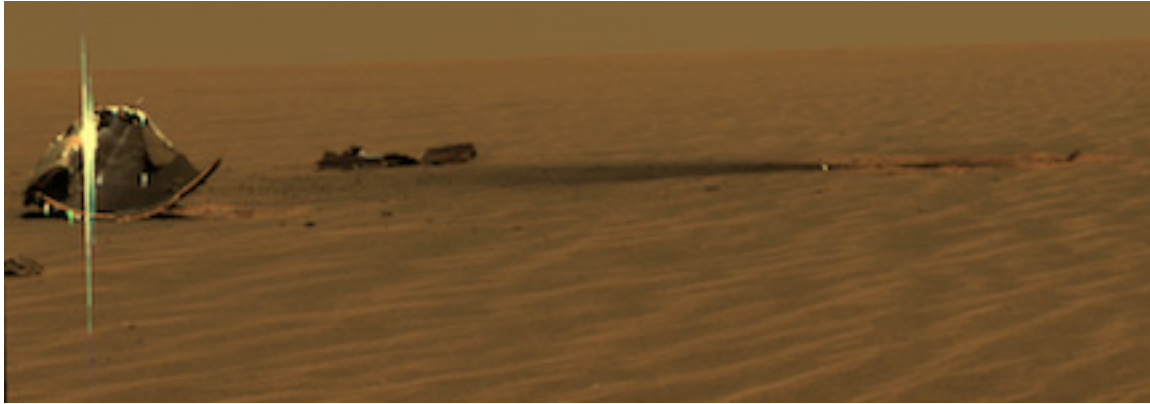
**Figure 8. Images of the heatshield debris field taken from a 30 m distance (impact divot on right)**

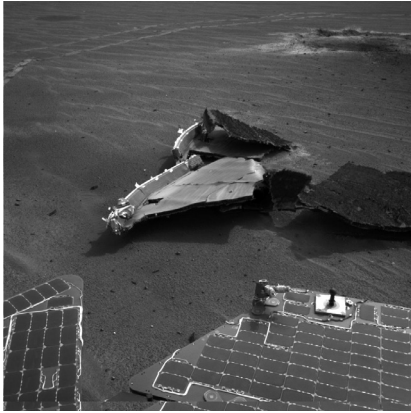
**Figure 10.** Sol 331 image of “flank” piece from the South (the rover’s solar panels can be seen in the foreground)

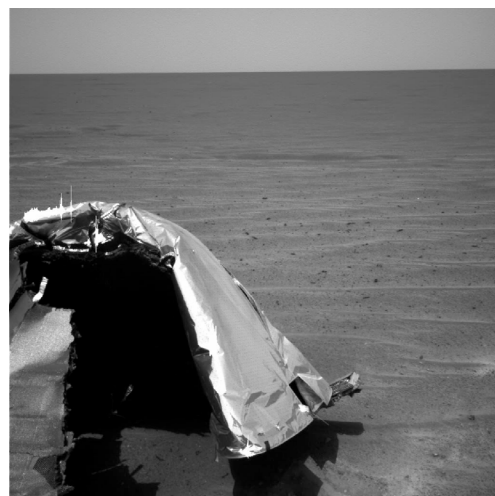
**Figure 14.** Main heatshield image in the attempt to view TPS surface characteristics

Before it was determined that the heatshield was inverted, it was hoped that observation of the global charring pattern on the exterior surface of the TPS would offer insight into heating gradients and transition to turbulence. Images were taken from various angles around the main heatshield, and at different times of the Martian day, to attempt to distinguish color patterns on the TPS. Unfortunately because the inverted position shadowed and blocked the interior, clear images of the TPS could not be obtained, as seen in Figure 14. However, this side of the main heatshield offered excellent cross section targets to obtain char depth measurements.

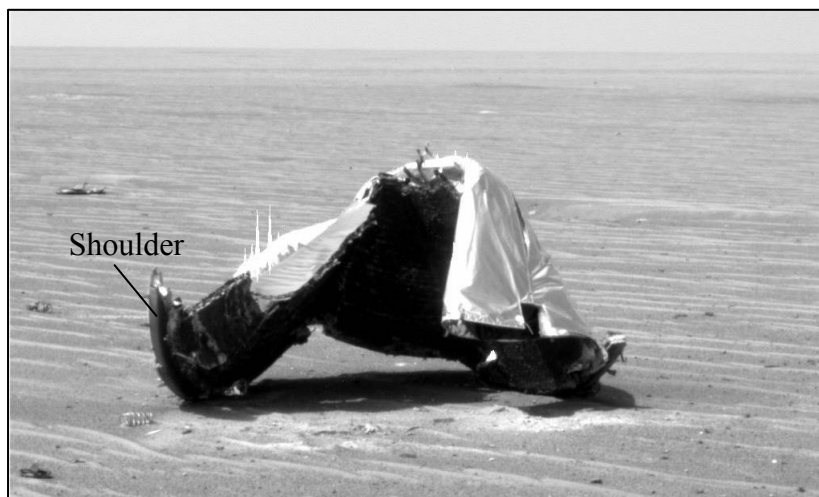
**Figure 15. Sol 329 image of the main heatshield from the west**

The heatshield shoulder is shown in Figure 15 and a close-up is shown in Figure 16, which also shows the MI target of the “flank” region cross-section. Figure 17 shows the mosaic MI results at this “flank” cross-section and shows significant impact damage to the TPS. Assuming the char layer has been removed, the remaining virgin material is estimated at a depth of 10.2 mm. A comparison to predictions is described later in the Analysis section. The “edge” location at the shoulder, as

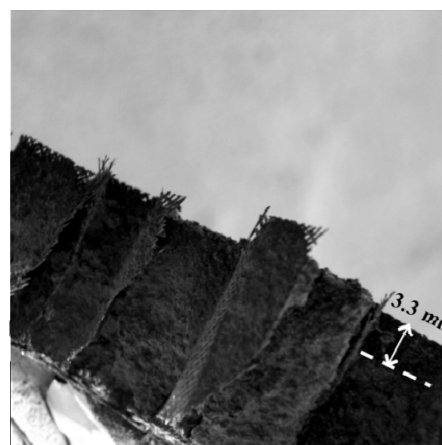
**Figure 19. MI image of heatshield edge with estimated char layer depth**

shown in Figure 18, turned out to be an excellent cross sectional view, and the MI results are shown in Figure 19. An estimate of the char depth, based on slight color variations, was made (3.3 mm) and a comparison to char thickness predictions is discussed in a later section. This data allowed engineers to achieve one of the main objectives of the heatshield observation plan. An interesting view and color image of the shoulder area is shown in Figure 20. The mottled appearance is likely due to heating gradient effects on the TPS at the shoulder region.

As expected, there is no measurable surface recession as SLA-561V performs mainly as a charring insulator. The Flank location is much more uniform in profile than the Edge section, which experiences varied environments due to the shoulder curvature. The two regions highlighted in Figure 31 (Flank and Edge) and imaged in Figures 17 and 19, are shown in greater detail in Figures 32-33 below. Here, the TPS is plotted as depth (measured from the TPS outer-mold line) vs. wetted length (measured from the stagnation point). The X and Y coordinates consistent with Figure 31 are also shown. The char thicknesses determined from Figures 17 and 19 are included for comparison.

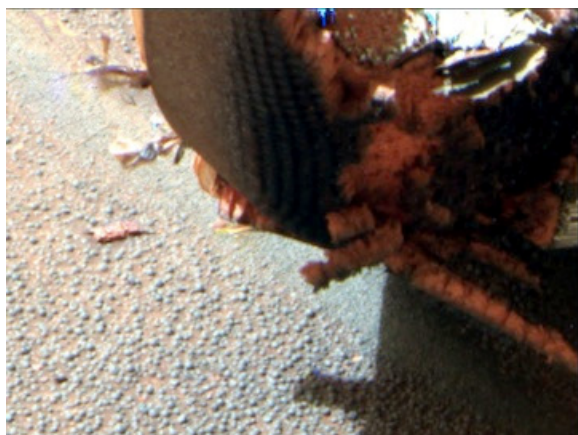
**Figure 20. Color image of heatshield shoulder**

There is the opportunity for forward work to improve comparisons with the MI and other photographs (namely Figures 16, 18, and 20). Additionally, material studies of MSL test-era SLA-561V charred and virgin samples, such as Thermo-Gravimetric Analysis, may provide better mapping of TPS cross-section coloration to material density. This better density mapping, along with FIAT Monte-Carlo simulations<sup>15</sup> will be used to better define the pyrolysis zone and predicted uncertainty. Future studies will also address angle-of-attack variation and TPS blowing, which should have minor effects on the in-depth material performance.

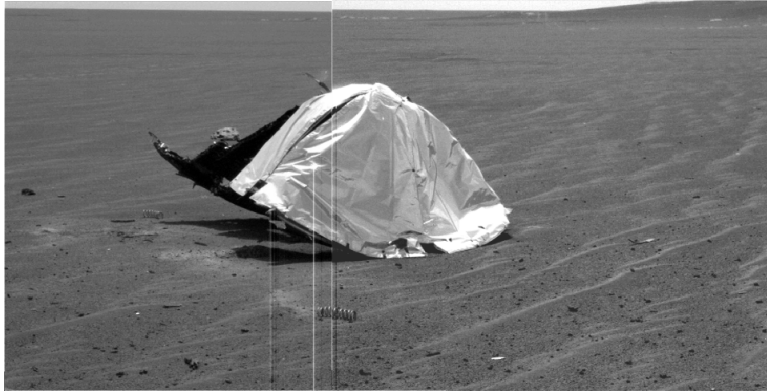
**Figure 21. Sol 335 image of the heatshield (“heatshield rock” can be seen just behind the heatshield)**

Figure 21 shows the internal MLI blanketing, a separation spring, and fortuitously, a rock that intrigued the MER scientists. A color image from Sol 357 (Figure 22) revealed the heatshield composite structure, fractured and rippled from the high-speed impact into the Martian surface. These color images showed no observable discolorations on the structure or internal MLI blanketing that would indicate overheating. Many of these elements are quite thin, and thus very susceptible to thermal damage, particularly the aluminum honeycomb and MLI, so these visual results are quite conclusive. This result achieved the fourth main objective of the observation plan.

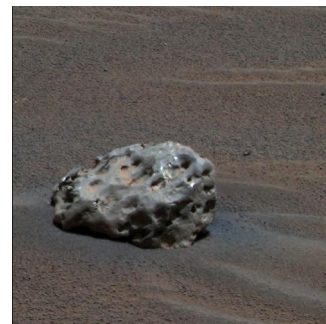
**Figure 25. “Heatshield Rock”, the first ever meteorite identified on another planet**

*Opportunity*’s heatshield fortuitously landed near a unique, basketball-sized rock (Figure 25), aptly named “heatshield rock” by MER scientists. During the heatshield observation campaign, the scientists took a detour around the heatshield to gather spectroscopic data on the rock to aid in its identification. Surprisingly, it was determined to be an iron-rich meteorite, and the first meteorite of any type ever to be identified on another planet. This unexpected science “gem” could open up research possibilities for future robotic and sample return missions.
